Report No. BC/MB/08.22.04.

**Coal Mining Risk Assessment:
Land at Cwmamman Road,
Glanamman, Ammanford.**

Brecon Eco Homes Ltd.

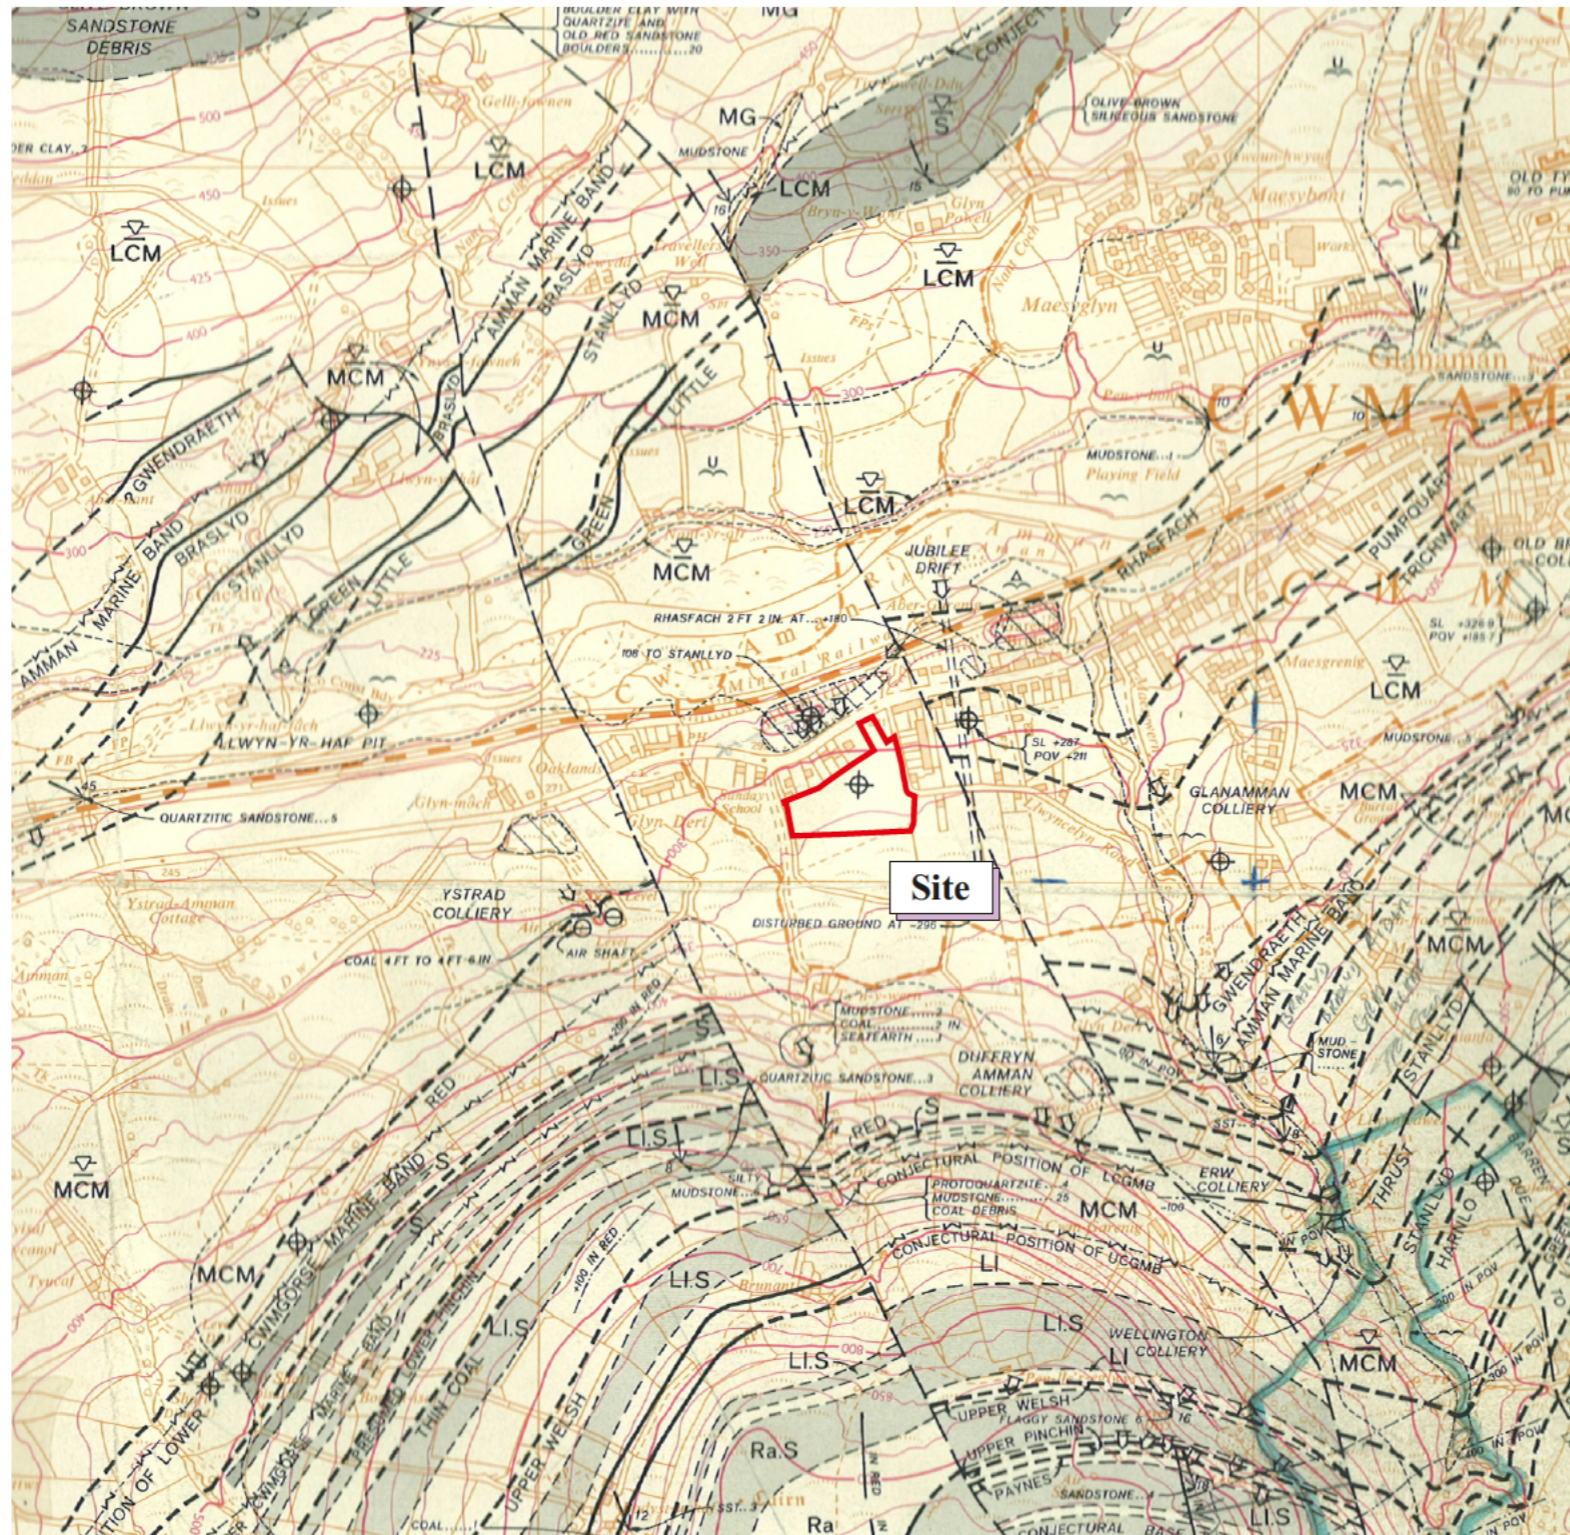
Geology Plan.

There are records of disused colliery entries, both shafts and adits, within the confines of the Site and the immediately surrounding area (see *Geology Plan, drawing no. BC/MB/08.22.04.02*). A pair of disused adits and a disused air shaft are present approximately 50m west of the north-western corner of the Site, immediately to the north of the A 474; two further disused adits are also present in the same area. This cluster of disused mine entries indicate that a significant mining operation was once present, probably exploiting either the Ddugaled Rider or Ddugaled Seam. Workings associated with this mining operation would extend beneath the Site at relatively shallow depths.

A disused air shaft is also present within the confines of the Site (see *Geology Plan, drawing no. BC/MB/08.22.04.02 and The Coal authority's report in the appendix*).

Mining records indicate the presence of a disused air shaft within the confines of the Site. The Coal Authority has no record that the shaft has been stopped up to an acceptable engineering standard and it must be presumed, until proven to the contrary, that it poses a risk to any surface development there.

To militate against any interaction in the event of the shaft collapsing, no hard development should take place within an exclusion zone to be determined until the risk of interaction has been fully assessed and appropriate protection measures included. The exclusion zone should be based on the findings of an examination of ground conditions in the immediate vicinity of the shaft.

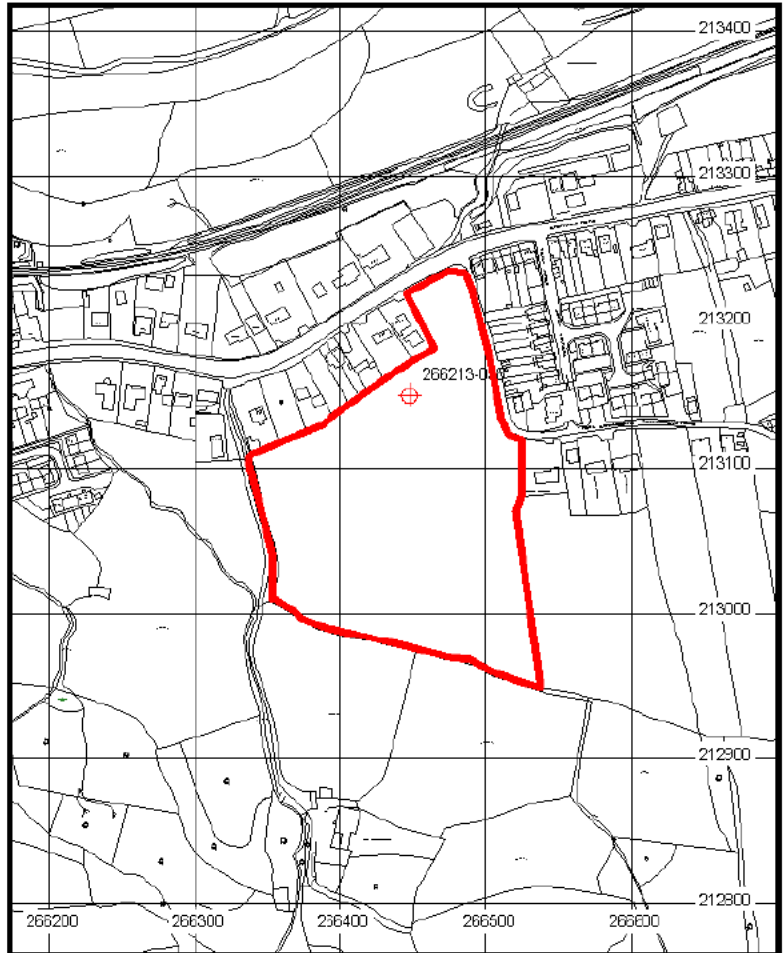
Within, or within 20 metres of, the boundary of the property there is 1 mine entry, the approximate position of which is shown on the attached plan.

There is no record of what steps, if any, have been taken to treat the mine entry.
